**National
Transportation
Safety Board**

Rail Accidents Involving Crude Oil and Ethanol Releases

Crude Oil and Ethanol Accidents

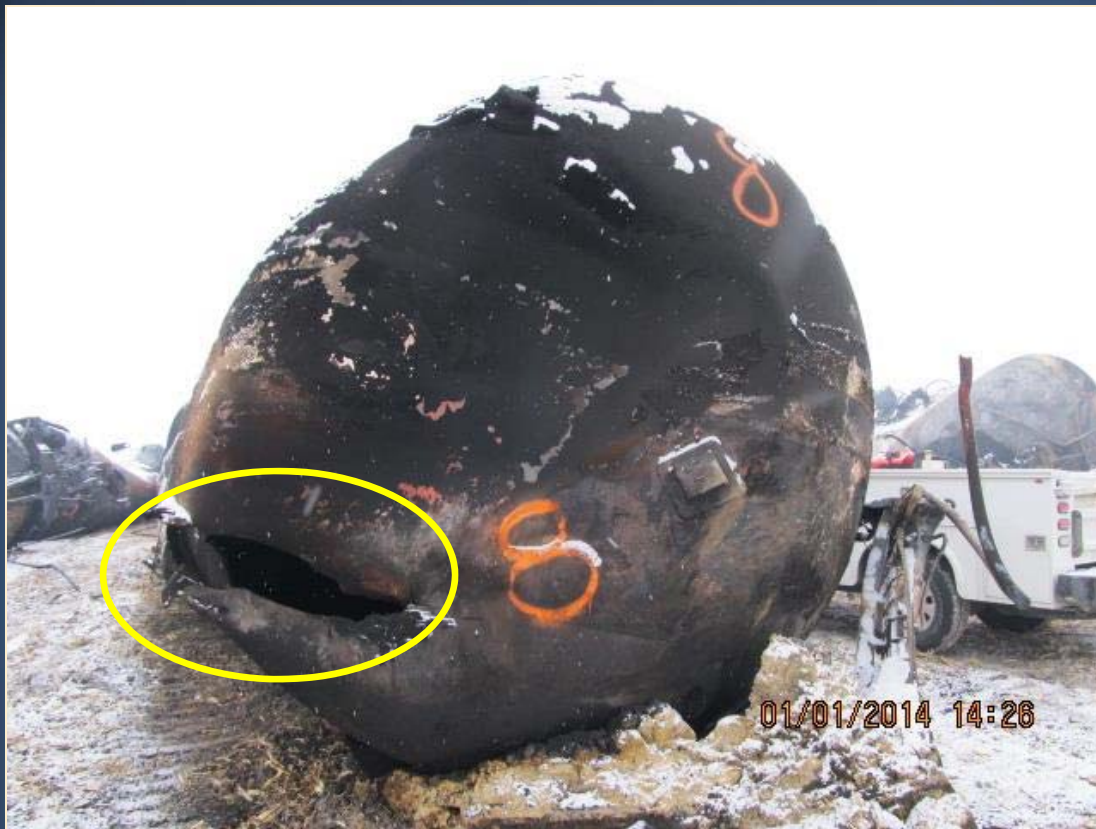
Lac-Mégantic, QC, 2013

Head Puncture

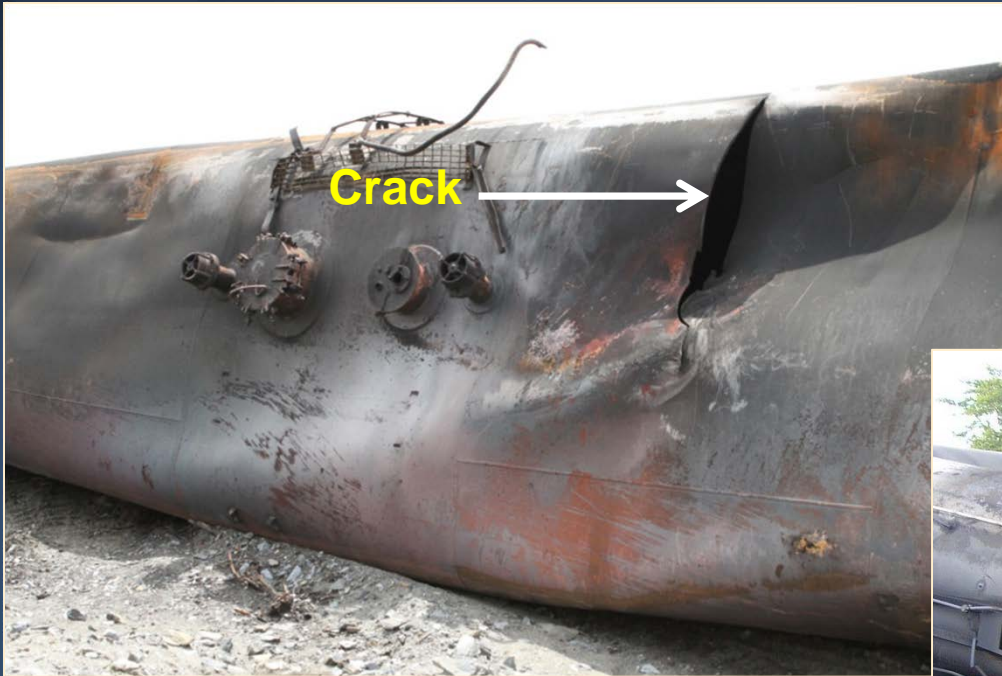
Shell Cracking and Tearing

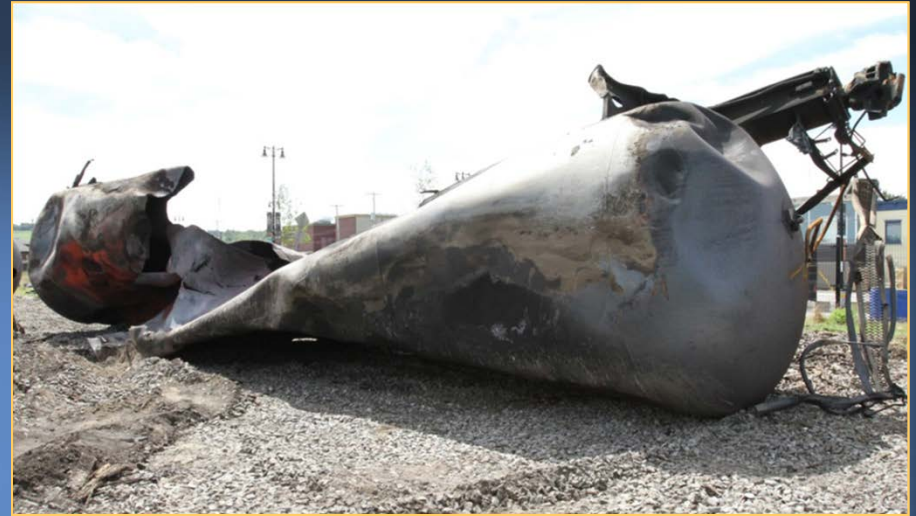
Lac-Mégantic, QC, 2013

Loss of Containment Volume

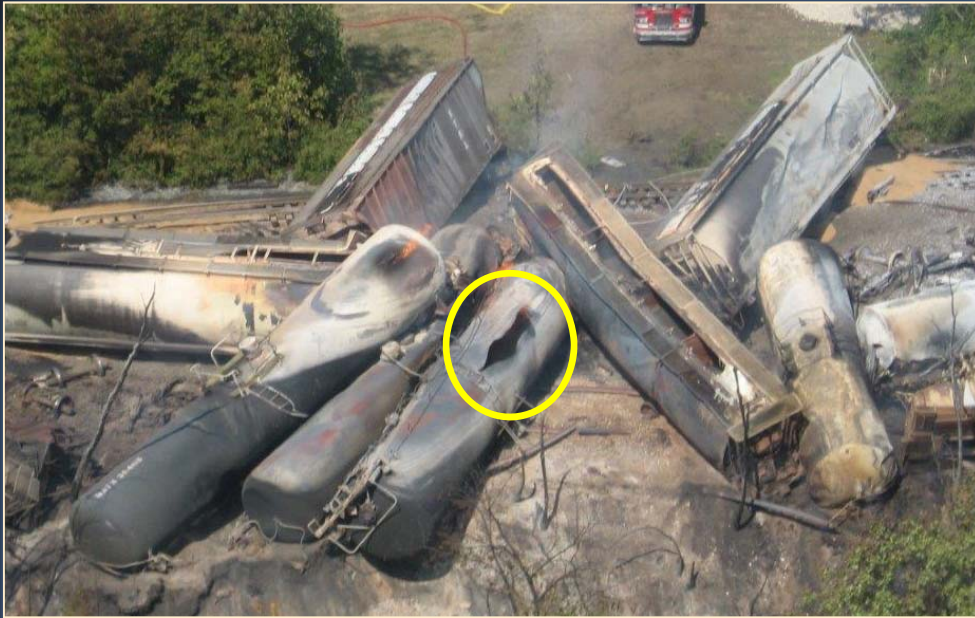
Thermal Failure and Fireball Release

- No tank jacket
- No thermal protection
- Insufficient pressure relief capacity

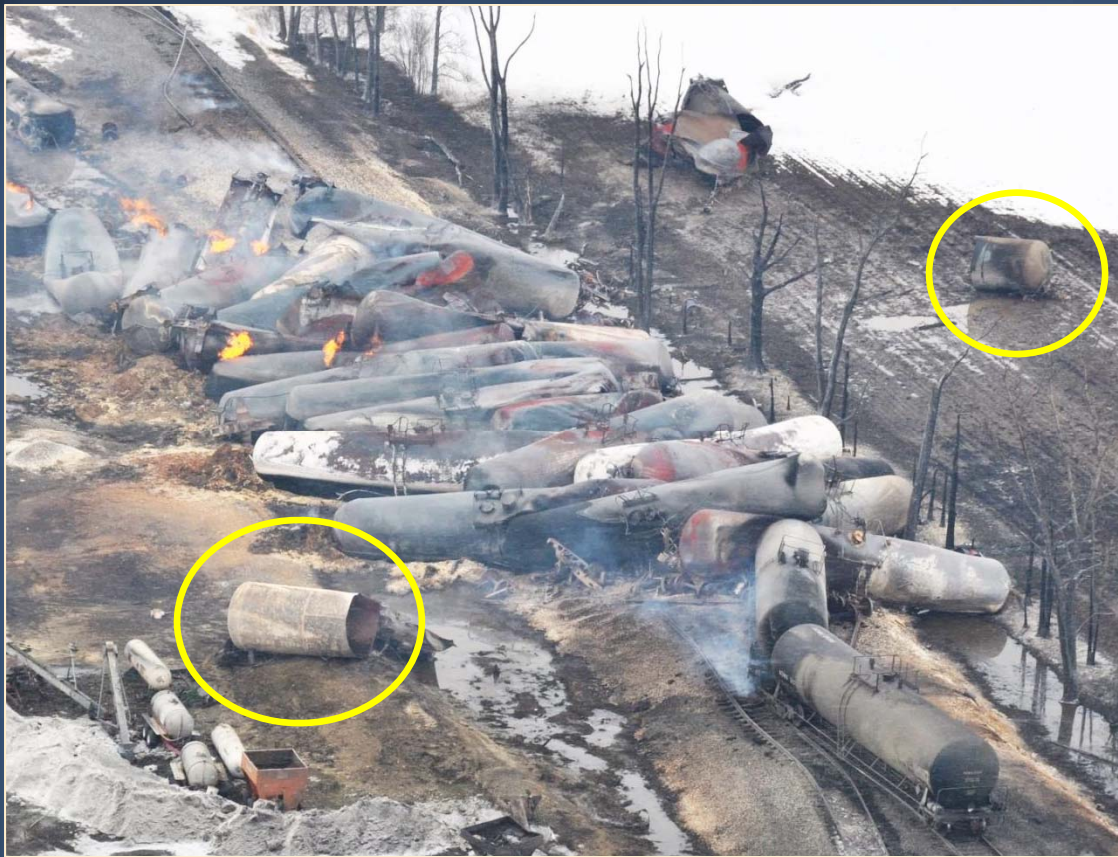
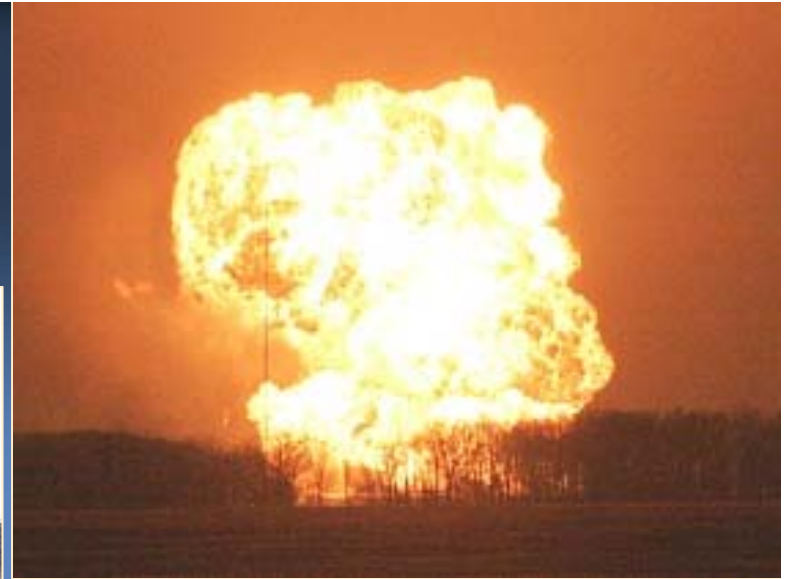
Arcadia, OH, 2011

Energetic Ruptures

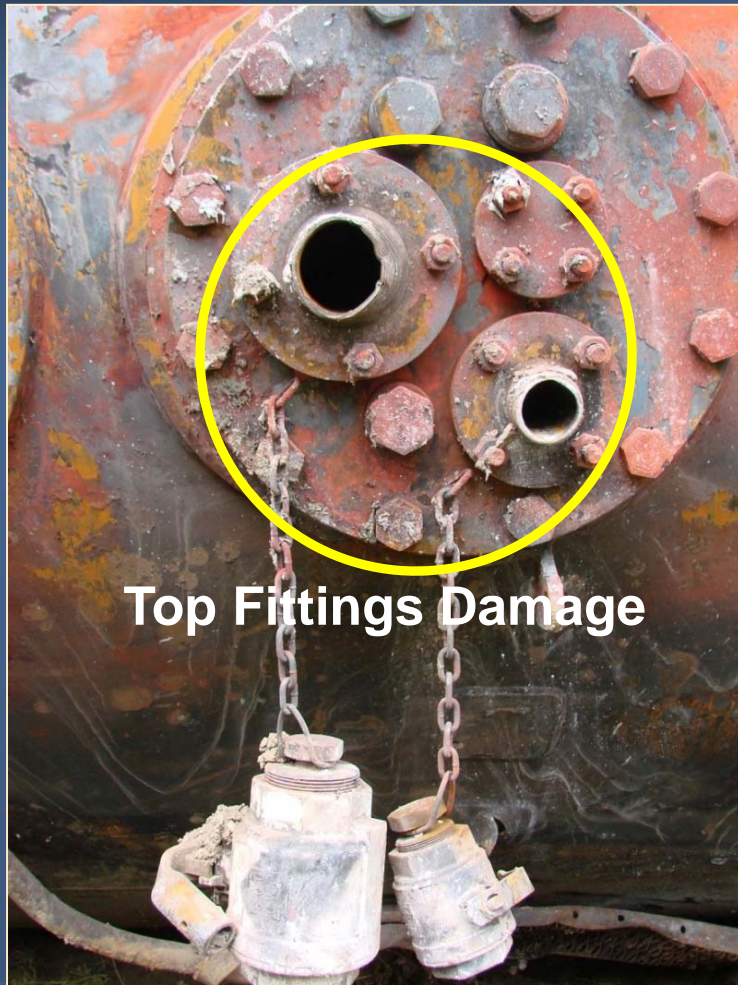
Cherry Valley, IL, 2009

Top and Bottom Fittings Vulnerability

- Fittings not adequately protected

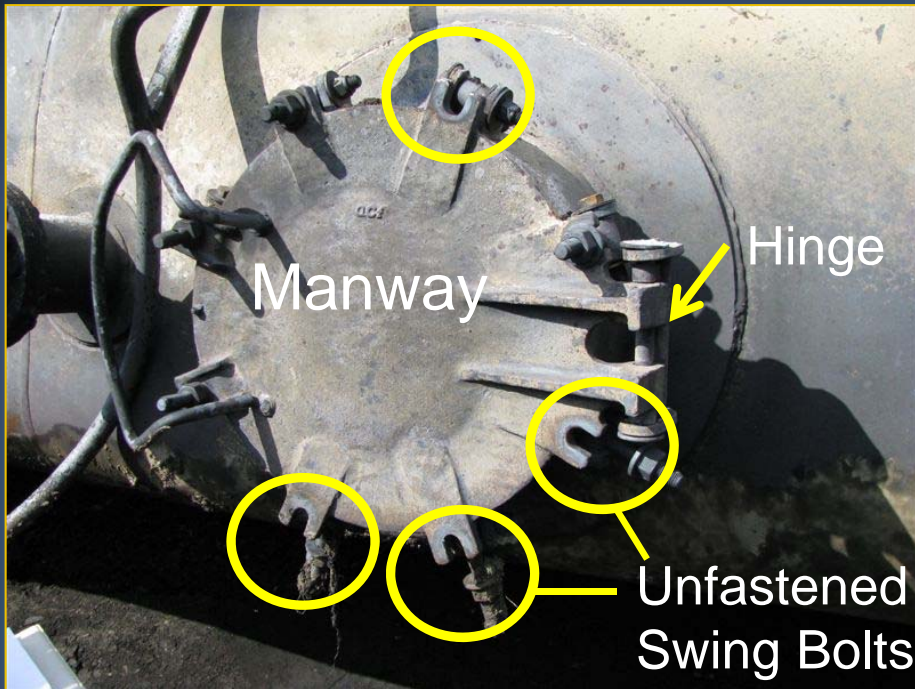
Lac-Mégantic, QC, 2013

Top Fittings Failures
